2018 Master Plan

September 2018

The Cuba-Rushford Central School District, located at 5476 Rt. 305, Cuba, NY 14727 retained the services of SWBR to provide a 21 Year Master Plan.

Elementary School Building Condition Assessment

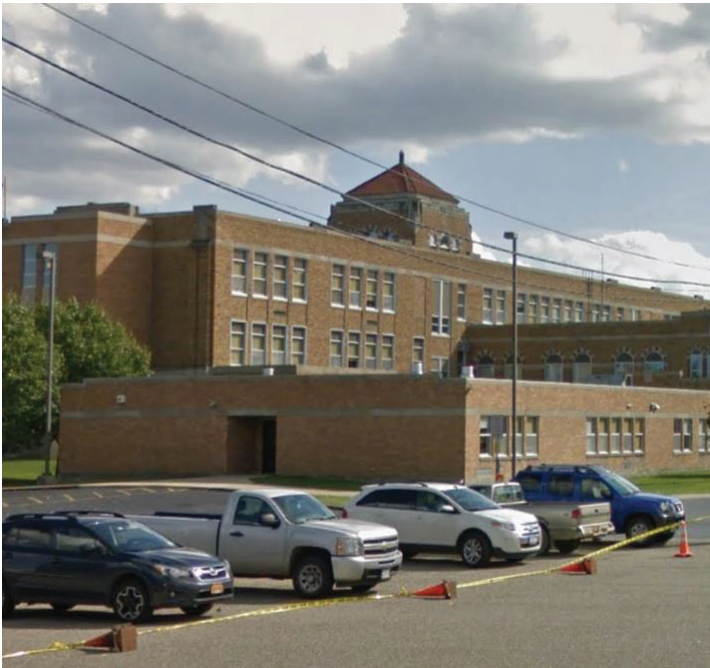
Elementary School

The building, located at 15 Elm St, Cuba, NY 14727, was originally built in 1937 with additions in 1960, 1970 and 1978. The building is approximately 98,131 square feet in size and has a current enrollment of approximately 478 students, Pre-Kindergarten through Fifth grade.

Site recommendations include a reconfiguration of the existing parking lot/bus drop off areas. The proposed solution provides a better flow of traffic while separating the parent drop off area from the bus drop off area thus reducing any safety concerns about students walking thru the buses. An optional dedicated bus loop off Elm Street is shown. This also provides a roadway behind the building to the proposed new loading dock.

Architectural recommendations include window replacement to increase the amount of natural daylight into the proposed learning environments. Demolition of the 1960 temporary classroom addition allows for the proposed parking lot to be achieved.

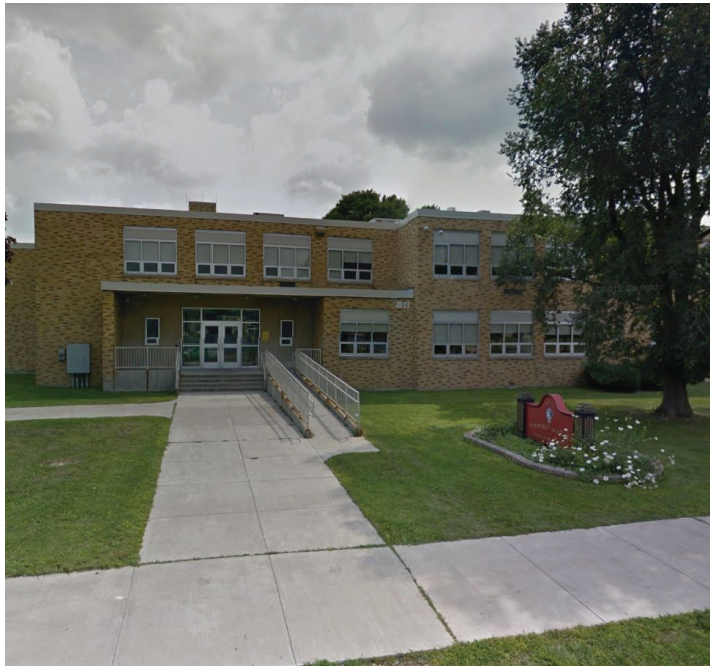
Elm Street Academy

The exterior wall construction is brick-veneer with masonry (based on vintage assume speed tile, cement block or CMU) back-up and a structural steel framing system. The roof system consists of a single ply membrane system installed in 2004 with approx. 15 years of expected life left. The exterior doors consist of either aluminum doors and frames or hollow metal doors and frames. Exterior windows are aluminum frames (approx. 15 years old), in relatively good condition with approx. 10-15 years of expected life left. The building's interior spaces are inadequate and due for a general refresh. The overall condition of the building is satisfactory. The recommendations described as part of this report are not a comprehensive list of the District's needs, but rather touch upon some of the more significant issues at this building.

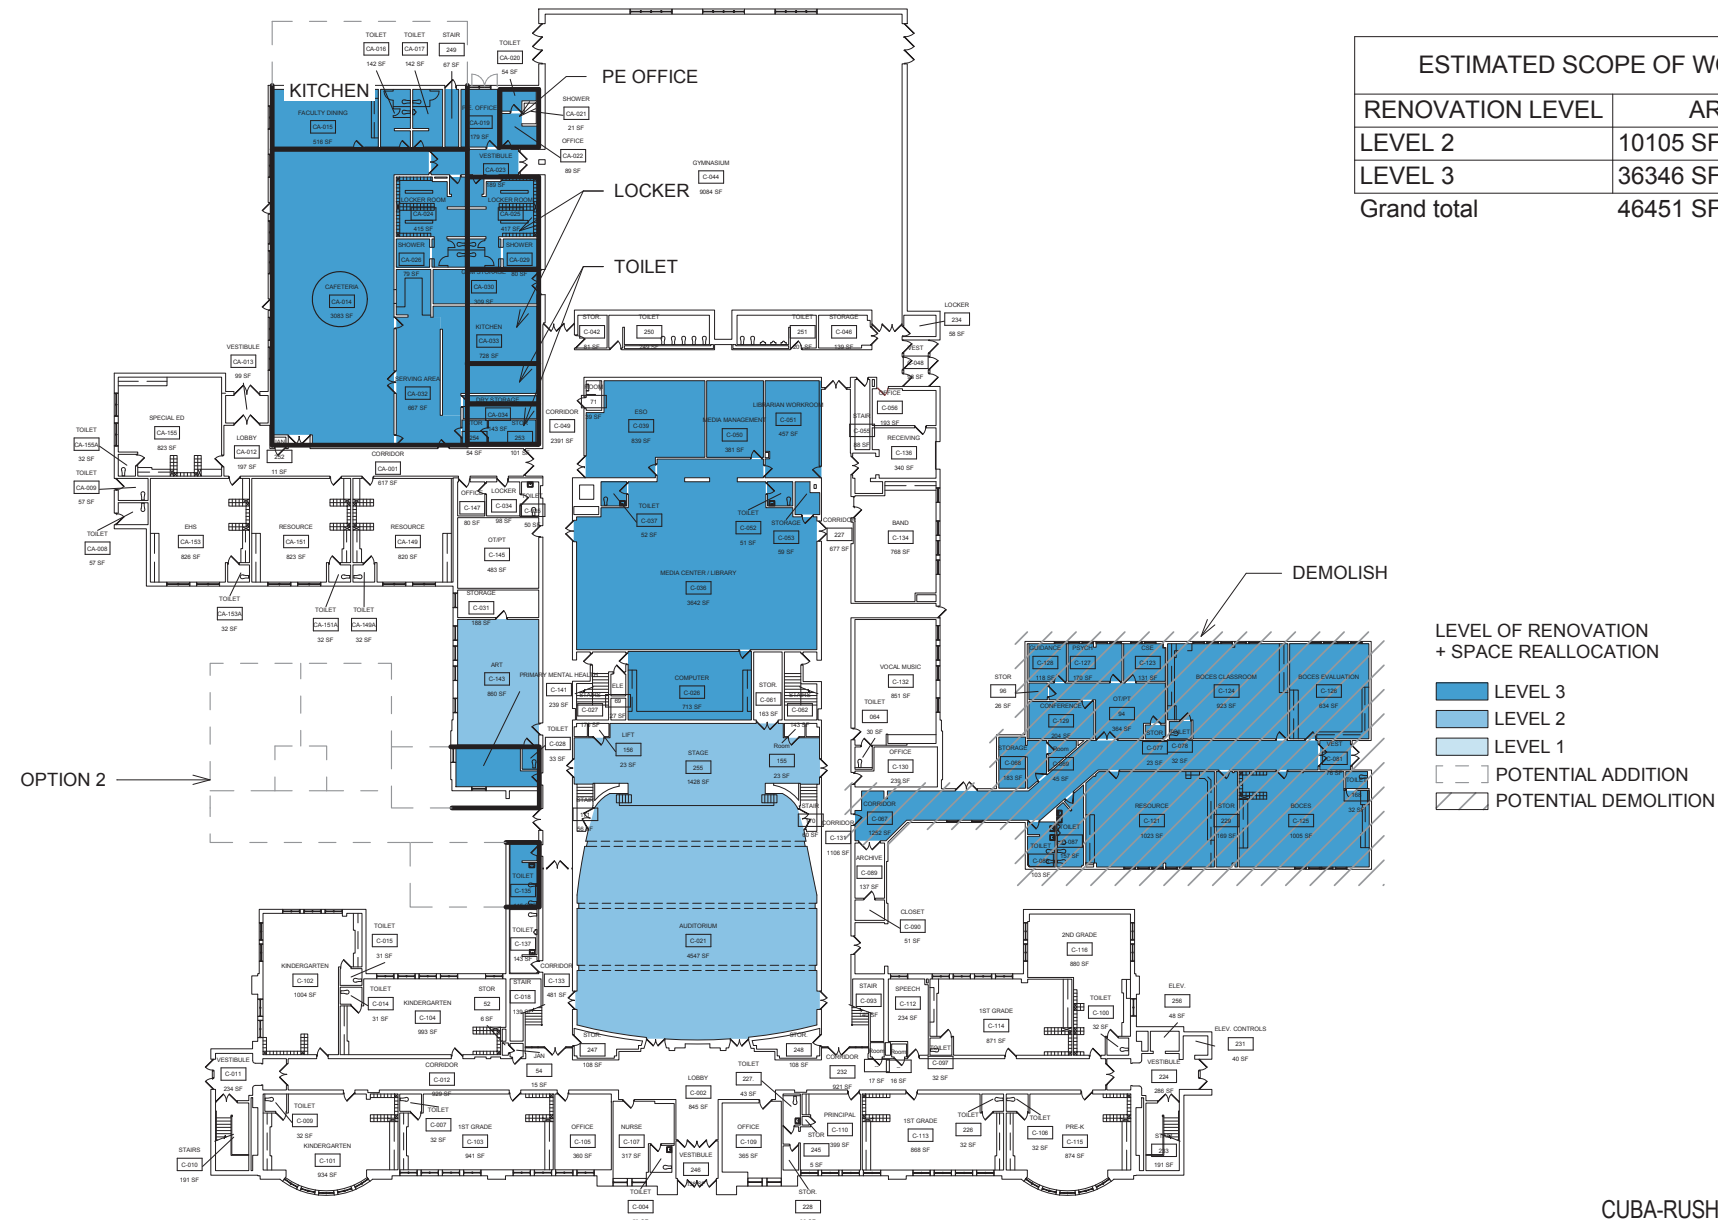
FIRST FLOOR

CONDITION ASSESSMENT PLAN - RENOVATION LEVEL

ESTIMATED SCOPE OF WORK	
RENOVATION LEVEL	AREA
LEVEL 2	10105 SF
LEVEL 3	36346 SF
Grand total	46451 SF

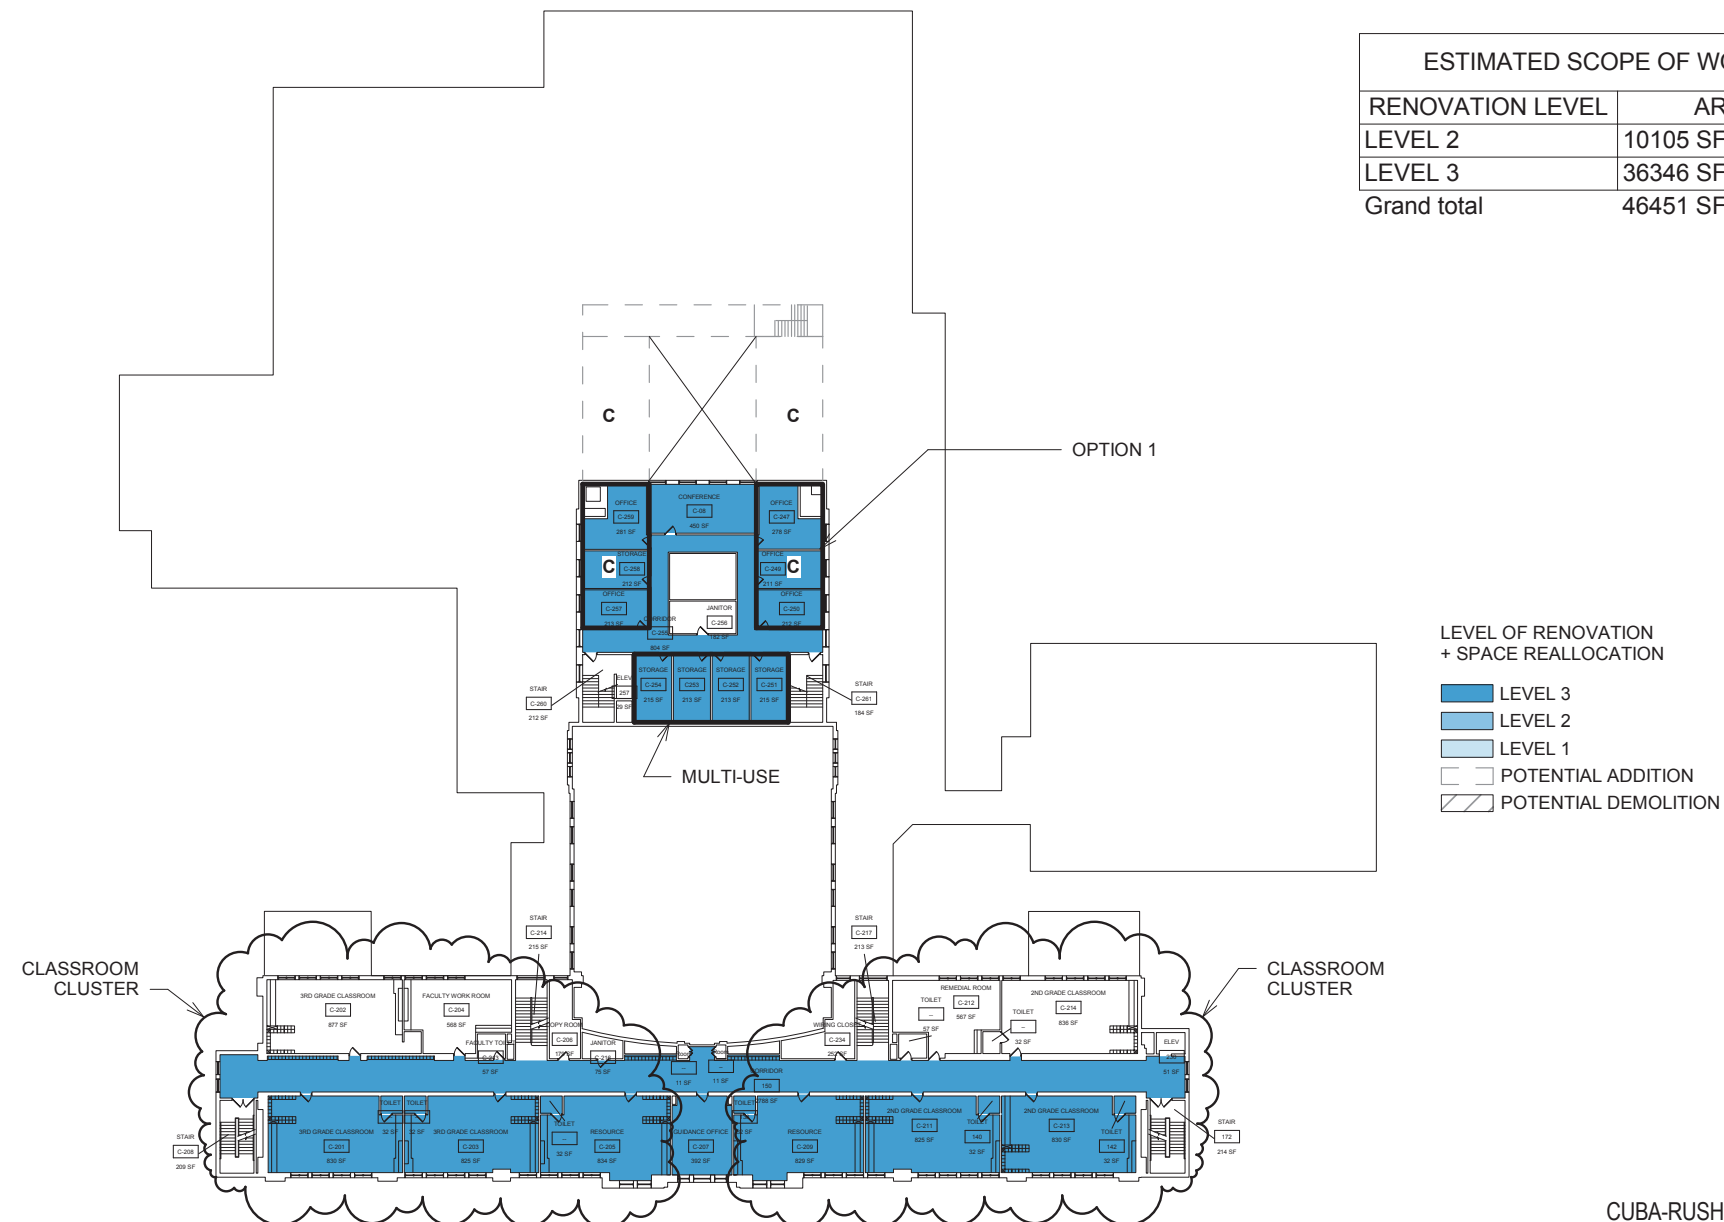
1 SECOND FLOOR
Not To Scale

CONDITION ASSESSMENT PLAN - RENOVATION LEVEL

ESTIMATED SCOPE OF WORK	
RENOVATION LEVEL	AREA
LEVEL 2	10105 SF
LEVEL 3	36346 SF
Grand total	46451 SF

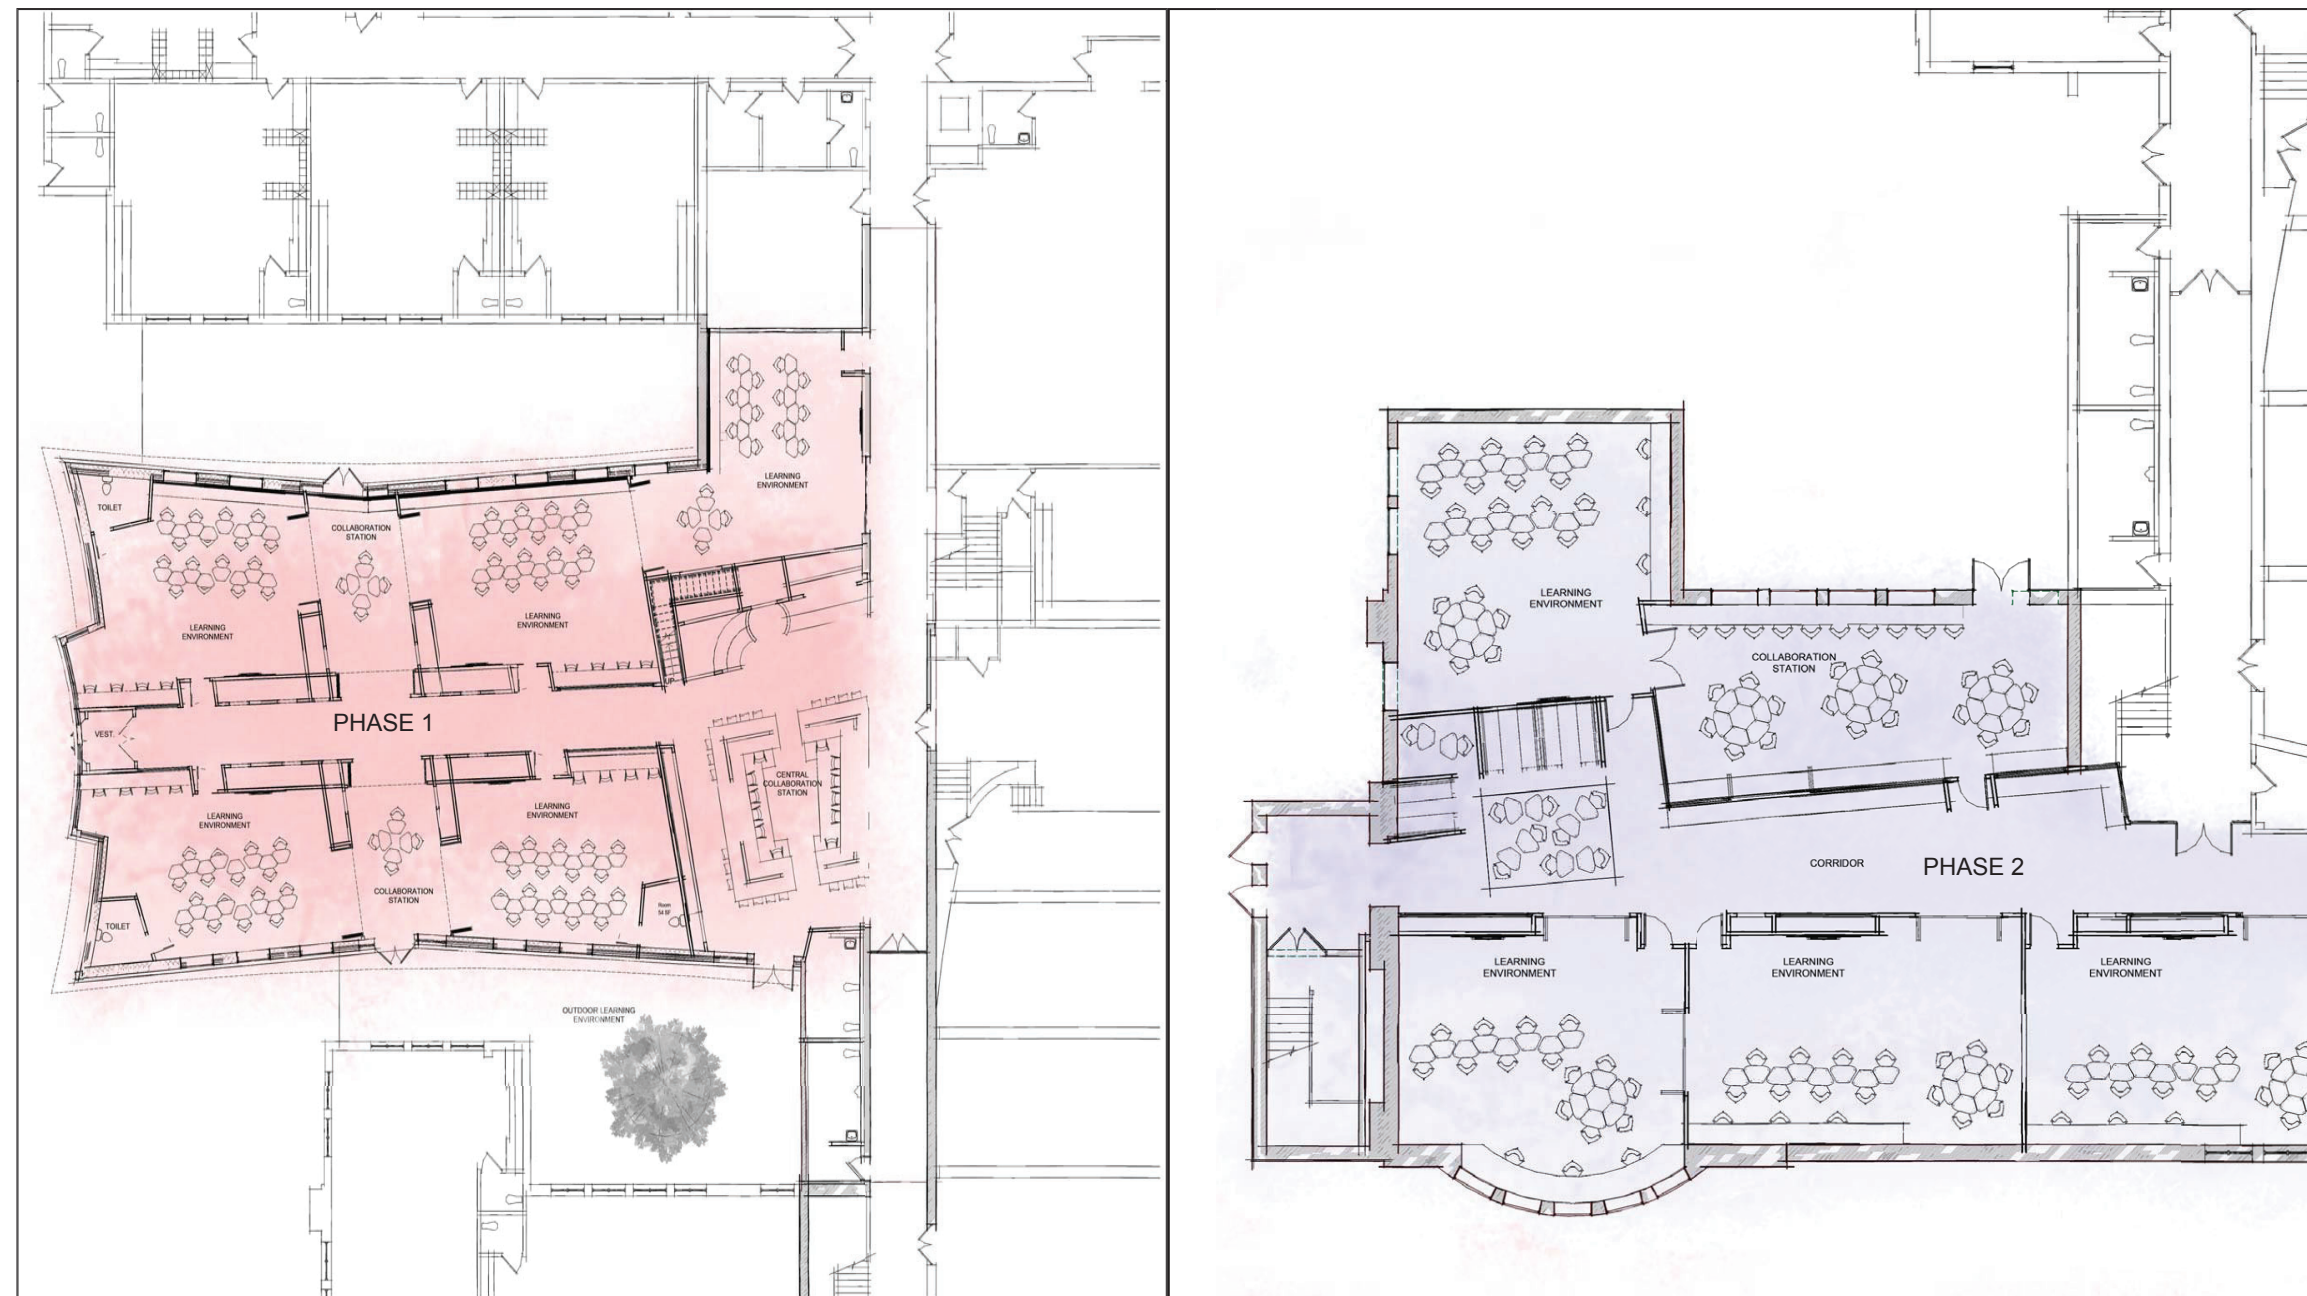
ELEMENTARY SCHOOL
FIRST FLOOR - POTENTIAL PHASE 1
CONCEPTUAL ADDITION

1ST, 2ND & 3RD FLOOR - POTENTIAL PHASE 2
CONCEPTUAL LEARNING ENVIRONMENTS

- To replace the educational space lost by the demolition of the temporary classrooms we have proposed two options for additions. The first is a single-story addition off the south of the building (shown on the plans as Phase I- Option 1A). The second option (shown on the plans as Phase I- Option 1B) is a second story addition/renovation over the media center.
- A renovation/addition to the existing cafeteria
- Relocate the loading dock to be closer to the kitchen and have its own area to prevent buildup of materials in the corridors.

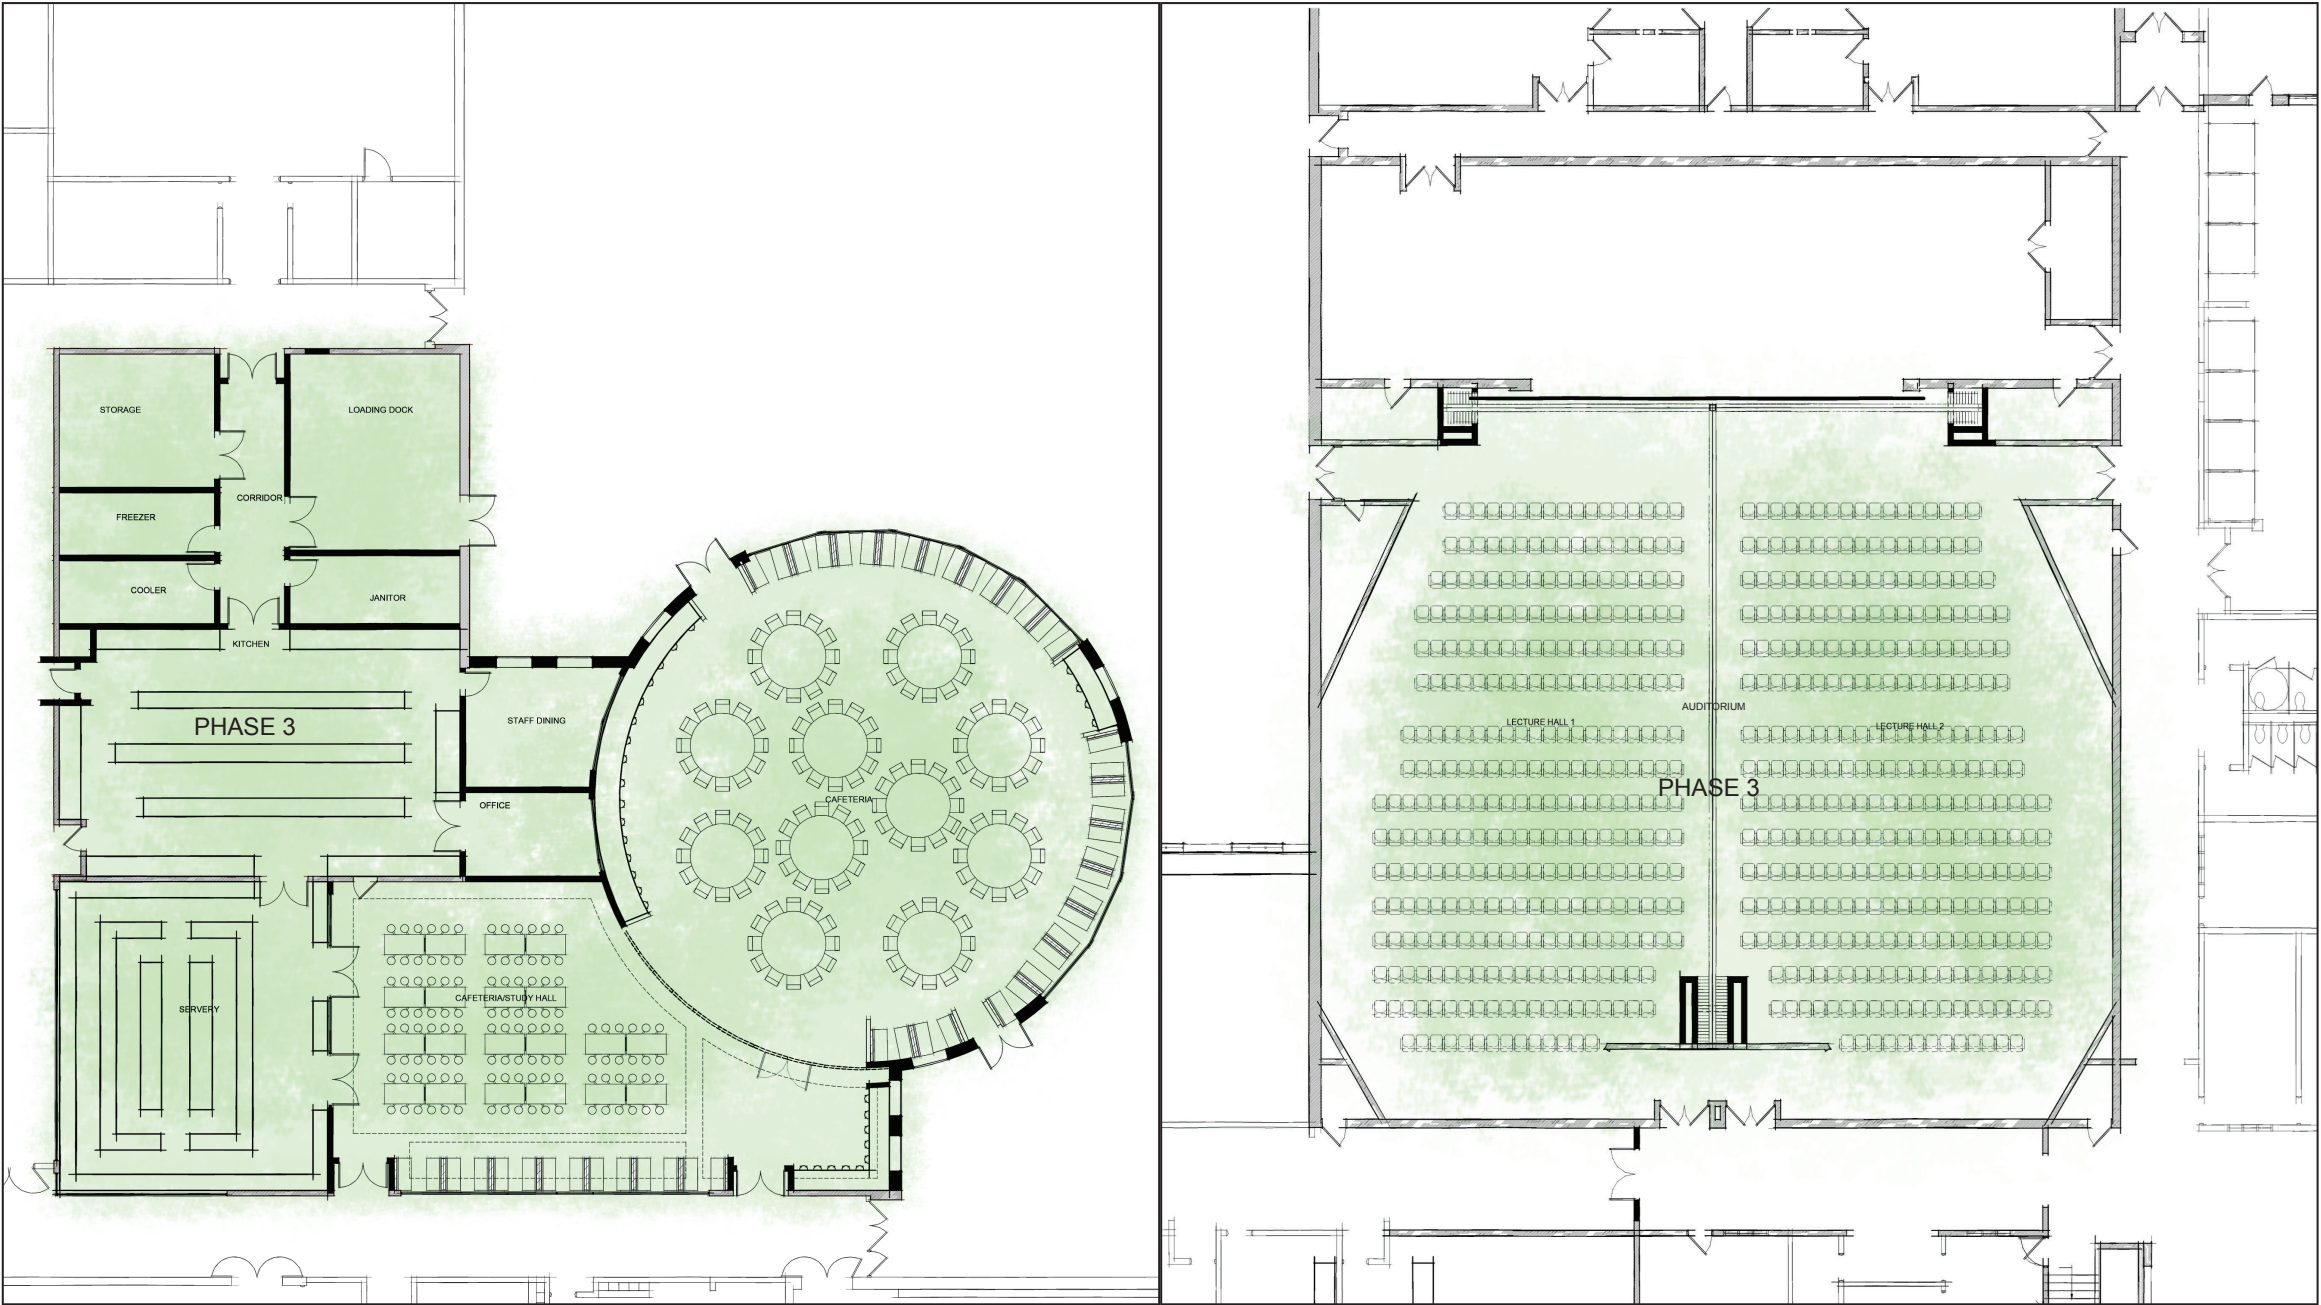
MIDDLE SCHOOL & HIGH SCHOOL
FIRST FLOOR - POTENTIAL PHASE 3
CAFETERIA & KITCHEN RENOVATION

FIRST FLOOR - POTENTIAL PHASE 3
AUDITORIUM LECTURE HALL RENOVATION

- Cafeteria renovation/addition
- Full renovation of auditorium. The purpose of this renovation would be to provide a large space when needed but also break the space down into smaller spaces to increase overall utilization.

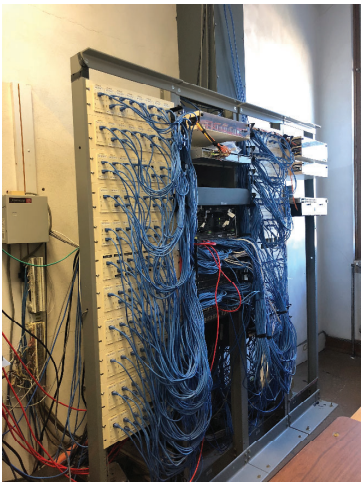
Figure 1: CRES Telecom Room #1

ECC identified locations in the Elementary School where cabling improvements should be implemented to better dress cabling and replace outdated patch panels. Refer to figures 1-3 below illustrating these conditions.
